Seismic behaviour of buildings Peter Fajfar

Intern. Conference on Seismic Design and Rehabilitation of Buildings

Tbilisi, 29. May 2014

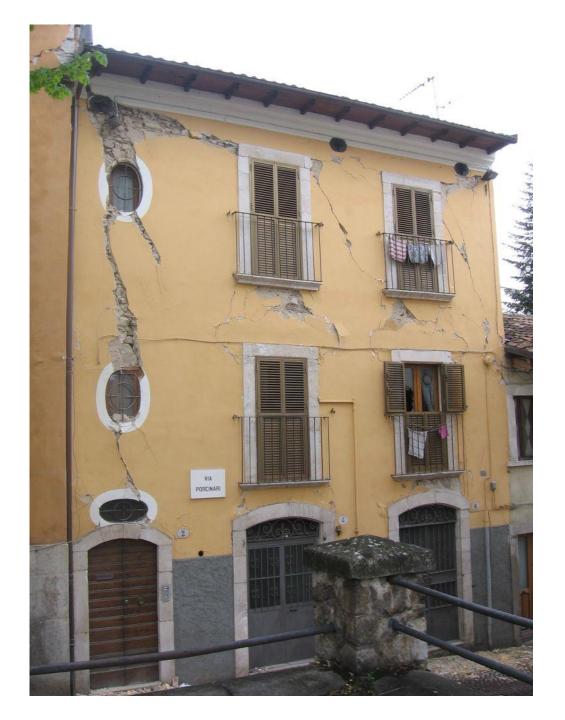
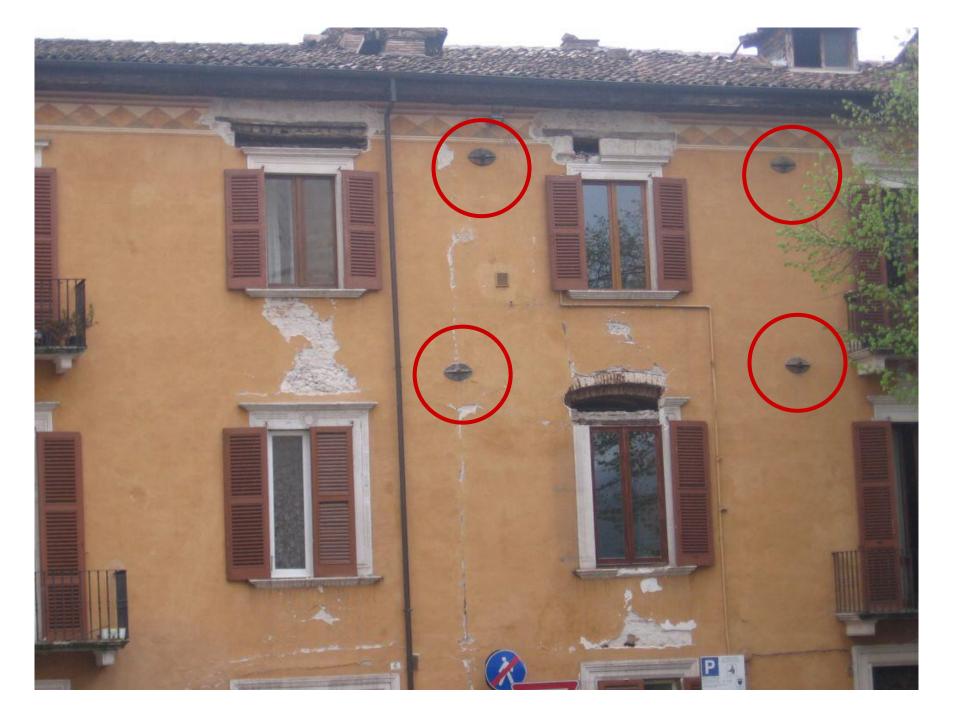
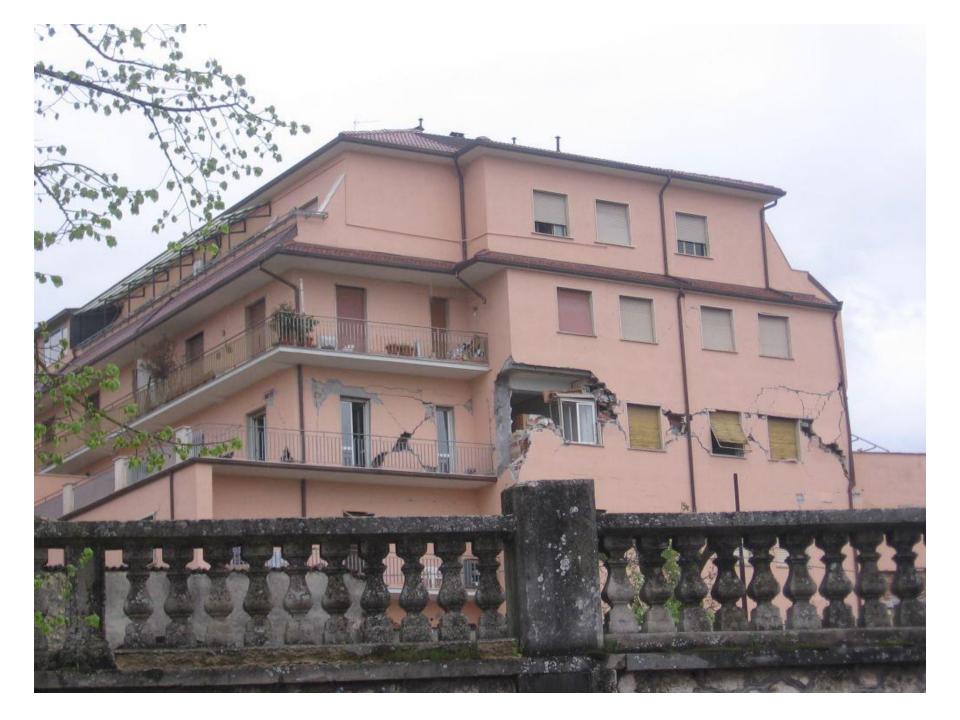
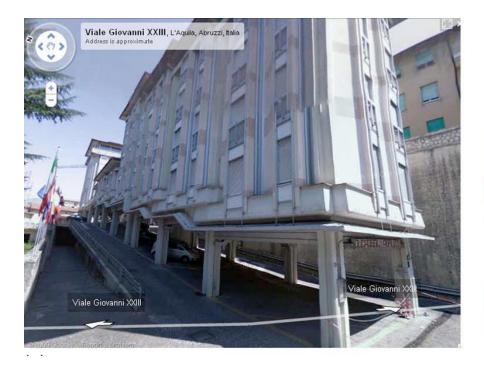
- Moderate magnitude, short duration, large intensity
- Heavy damage and complete collapses of many old masonry buildings
- Horizontal ties prevented collapses
- Heavy damage and complete collapses of some reinforced concrete buildings

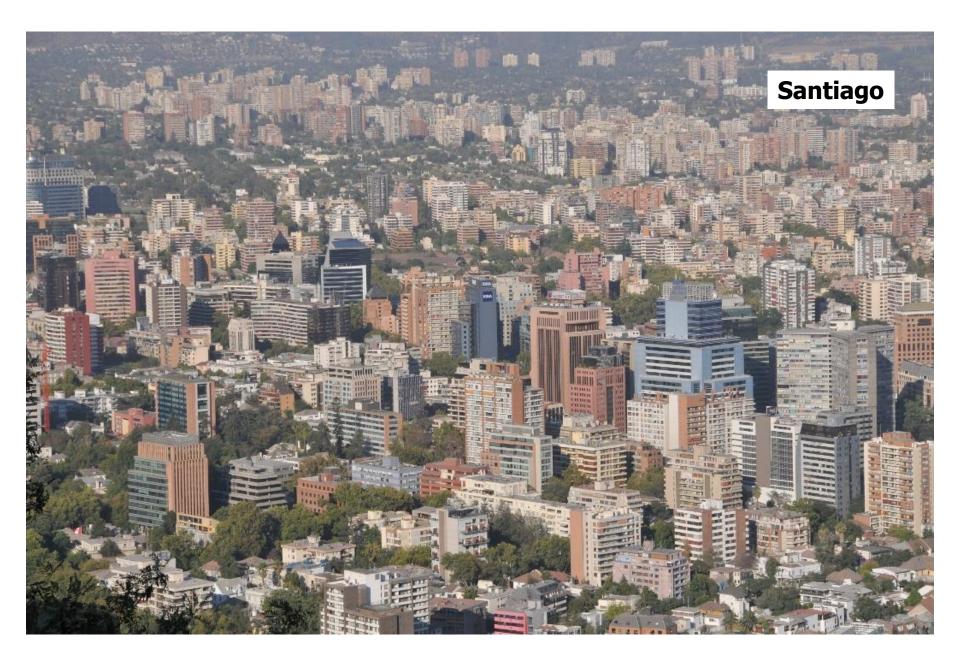
- Extreme magnitude, long duration, moderate intensity
- Majority of engineered structures behaved well
- Some buildings, including very new ones, heavily damaged
- New: Systematic local brittle failures of slender walls with large compression in new buildings, especially in first basement. Inadequate confinement for high axial stress.

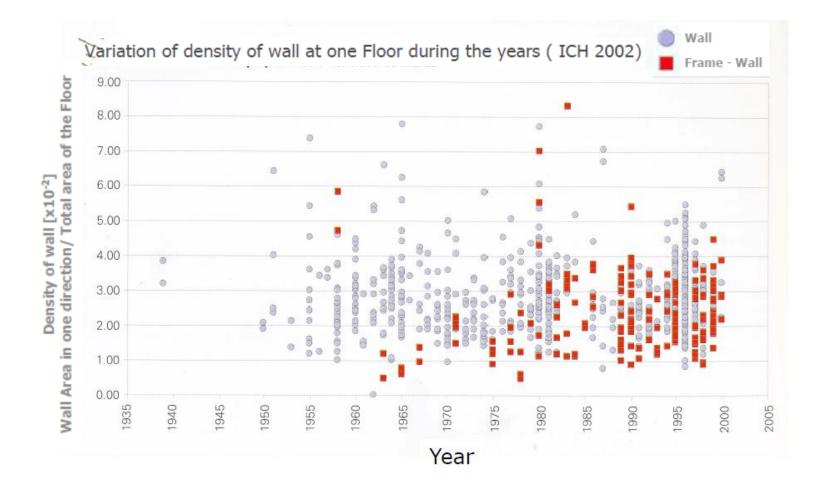
The area of walls as a fraction of the total floor area has remained about constant, but the number of stories has increased significantly, resulting in higher axial stresses in the walls. Vertical irregularities, mostly vertical setbacks (narrowing of walls near base –"flag wall" configuration)

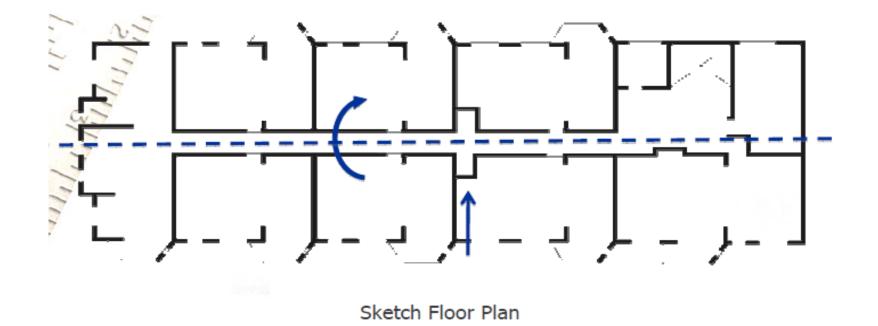
Alto Rio

- 15 stories, RC, Appartments
- 2 underground stories
- built in 2008

- 8 deaths
- 79 survivors
 - **52** came from building themselves
 - 27 rescued

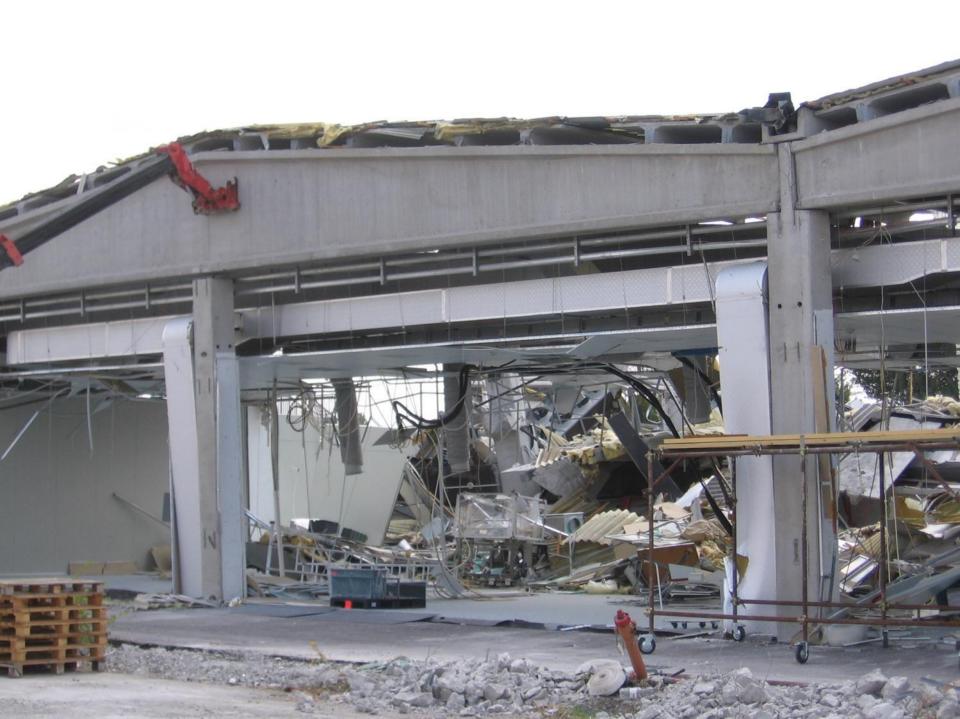
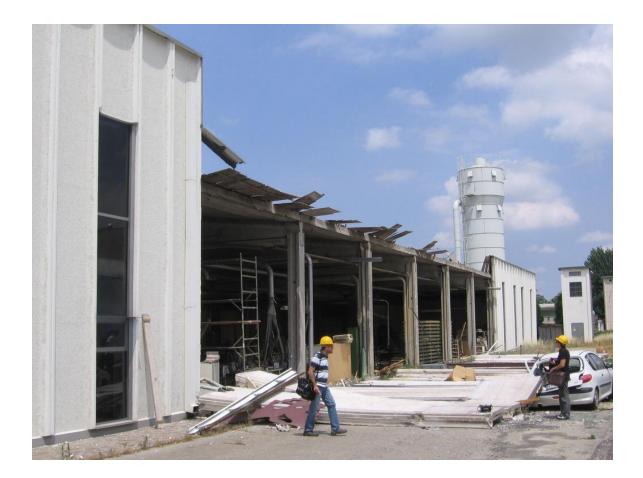
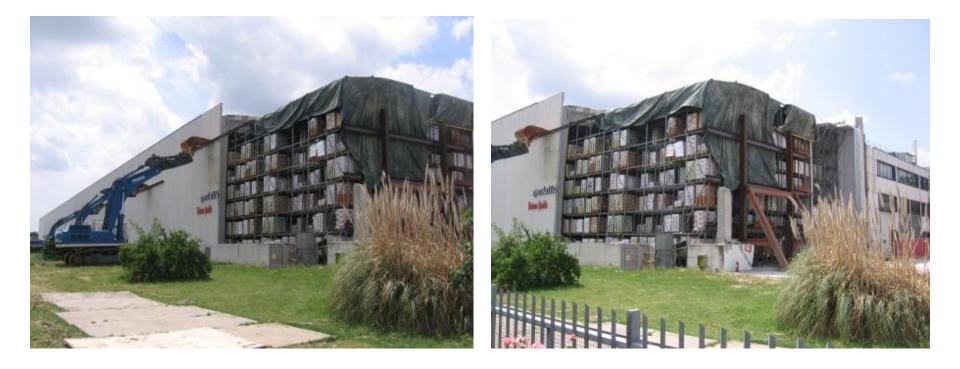
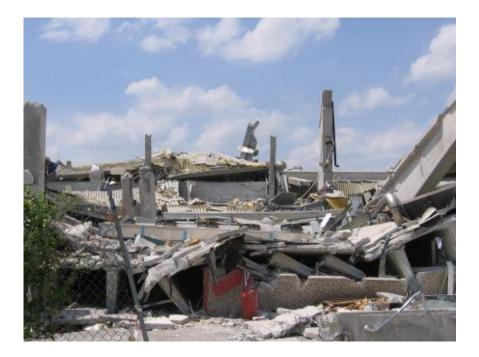
- Moderate magnitude, moderate intensity
- Heavy damage and collapses of masonry buildings, including cultural heritage buildings
- Heavy damage and collapses of numerous prefabricated RC industrial buildings, including relatively new ones
 - The region was until 2003 not defined as "seismic", in the period 2003-2006 the seismic design loads were quite low
