Seismic behaviour of buildings Peter Fajfar

Intern. Conference on Seismic Design and Rehabilitation of Buildings

Tbilisi, 29. May 2014

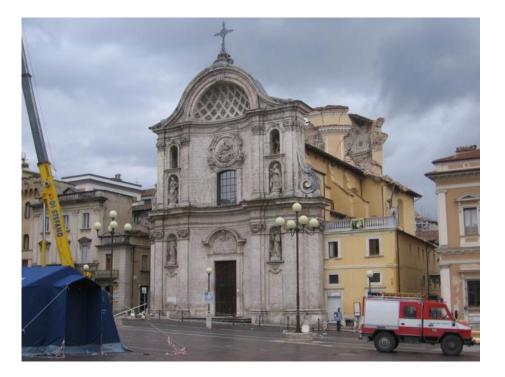
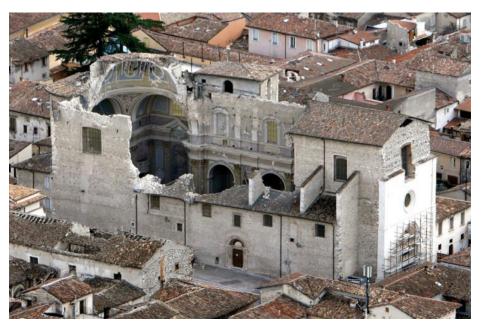
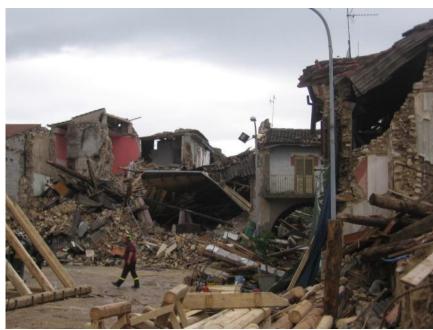
Italy L'Aquila 2009

- Moderate magnitude, short duration, large intensity
- Heavy damage and complete collapses of many old masonry buildings
- Horizontal ties prevented collapses
- Heavy damage and complete collapses of some reinforced concrete buildings

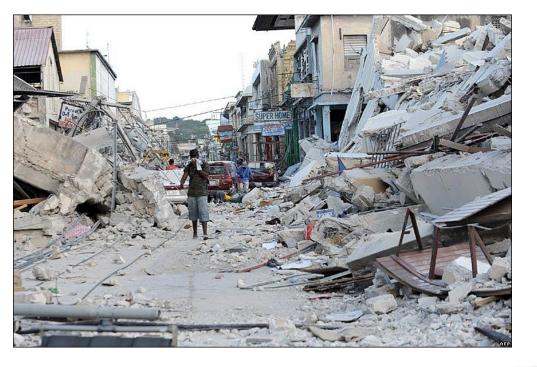
Haiti 2010

- M=7.0
- About 300.000 deaths
- About 300.000 wounded
- About 1,300.000 homeless
- Loss amounts to 120 % of GDP
- The most destructive earthquake that any country has experienced when measured in terms of the number of people killed relative to its population

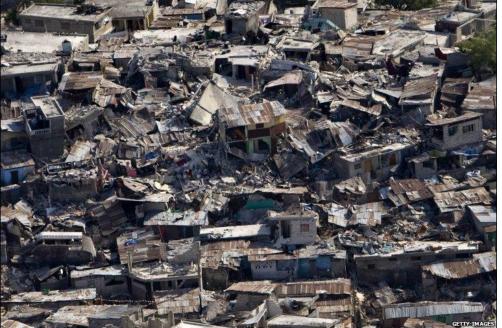
Haiti 2010

- Inadequate Construction Practice
 - Powerty
 - Lack of professionals in construction industry
 - No seismic code

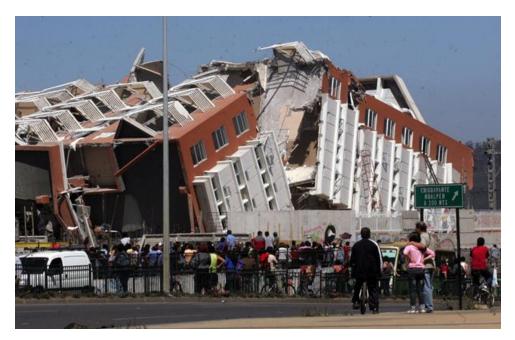
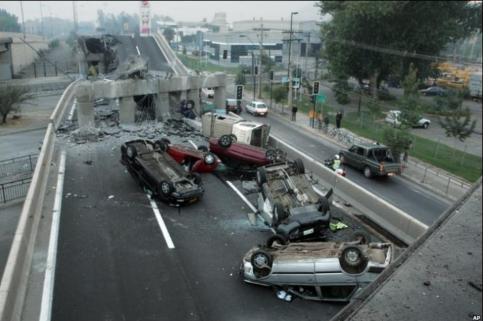
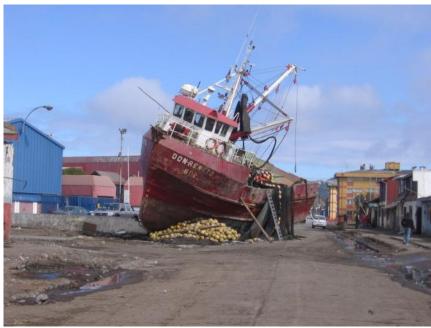
Chile 2010

- Extreme magnitude, long duration, moderate intensity
- Majority of engineered structures behaved well
- Some buildings, including very new ones, heavily damaged
- New: Systematic local brittle failures of slender walls with large compression in new buildings, especially in first basement. Inadequate confinement for high axial stress.

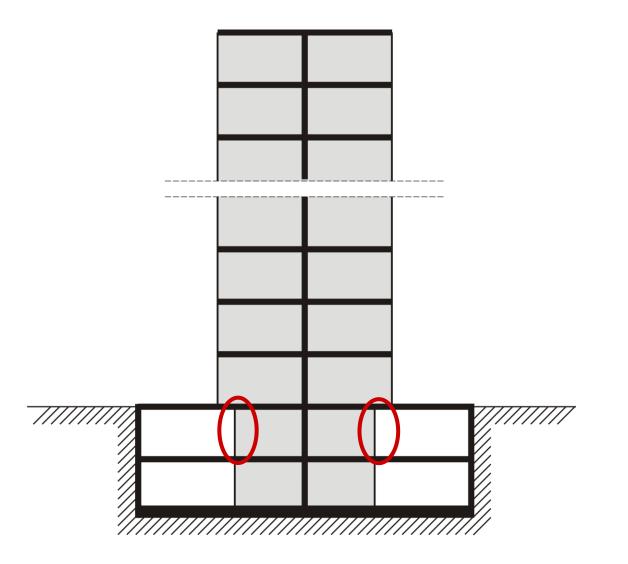
First basement

The area of walls as a fraction of the total floor area has remained about constant, but the number of stories has increased significantly, resulting in higher axial stresses in the walls. Vertical irregularities, mostly vertical setbacks (narrowing of walls near base –"flag wall" configuration)

Long duration of earthquake – a large number of loading cycles – and strong aftershocks

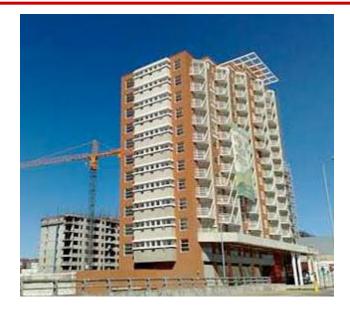
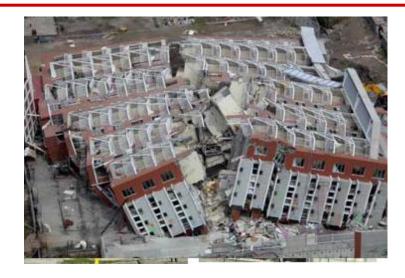
Alto Rio, Conception

- 15 stories, RC, Appartments
- 2 underground stories
- built in 2008

During the earthquake 87 persons in building

- 8 deaths
- 79 survivors
 - **52** came from building themselves
 - 27 rescued

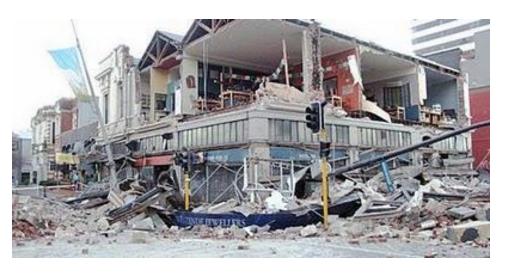
Christchurch 2010

- 4.9.2010: M=7.1, a_{gmax} = 1.26 g
- 22.2.2011: M=6.3, a_{gmax} = 2.20 g, 185 deaths
- 13.6.2011: M=6.3
- 23.12.2011: M=5.8
- Much stronger ground motion than expected
- Heavy damage (150000 homes damaged)
- Liquefaction
- More than 10000 aftershocks

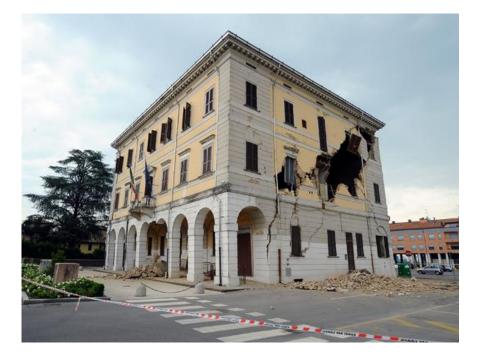
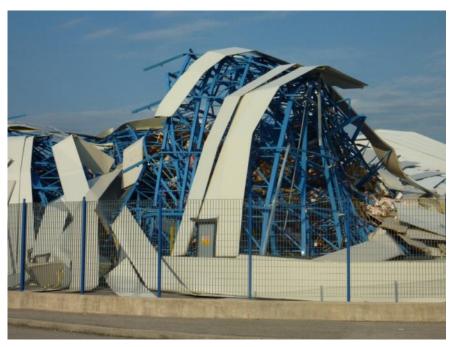
Emilia Italy 2012

- Moderate magnitude, moderate intensity
- Heavy damage and collapses of masonry buildings, including cultural heritage buildings
- Heavy damage and collapses of numerous prefabricated RC industrial buildings, including relatively new ones
 - The region was until 2003 not defined as "seismic", in the period 2003-2006 the seismic design loads were quite low
